WORLD SID-50M FITNESS ASSESSMENT IN FMVSS NO. 214 MOVING DEFORMABLE BARRIER AND OBLIQUE POLE CRASH TESTS

Whitney Tatem
Allison Loudon
NHTSA
USA

Paper Number 23-0340

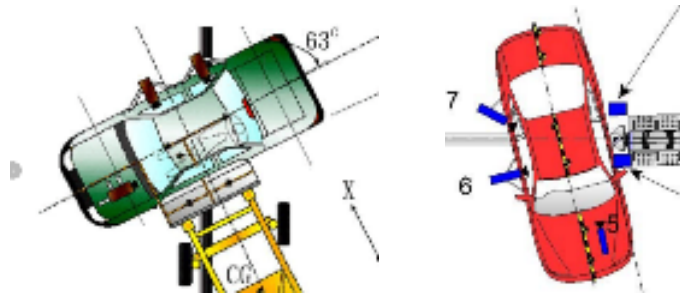
Figure 1. (L) Impact by the MDB, and (R) oblique impact with the rigid pole.

The eighteen crash tests were run by following FMVSS No. 214 procedures for either the driver (for left-side vehicle impacts) or the front passenger (for right-side vehicle impacts). For reference, the FMVSS No. 214 crash configurations are depicted in Figure 1. Eleven pole tests were conducted in accordance with the latest FMVSS No. 214 test procedure, TP-214P-01, dated September 2012. The first test of the series was conducted with a higher NCAP target test speed of 32.2 ± 0.8 km/h. Following this test, all the remaining ten pole tests were run at the compliance target test speed of 31.0 ± 0.9 km/h. Seven MDB tests were conducted in accordance with the latest FMVSS No. 214 test procedure, TP-214D-09, dated September 2012, and all run at the compliance target test speed of 52.9 ± 0.8 km/h⁴.

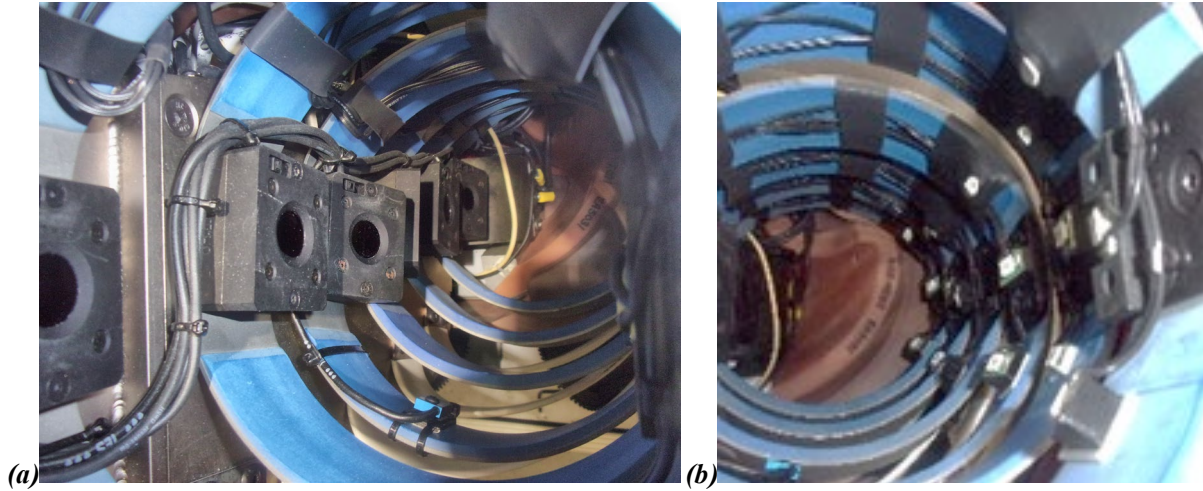
Figure 2. RibEye sensors (a) and LEDs (b) installed in a WorldSID-50M.

RibEye, manufactured by Boxboro Systems⁵, is a multipoint optical measurement system that is capable of measuring 3D rib deflection at multiple points on each of the six independent ribs of the WorldSID-50M. The RibEye consists of two groups of three sensors (receivers) mounted on the impact-side of the spine box, one at each rib level, as depicted in Figure 2(a). On the opposite side at each rib level are three LEDs per rib, mounted on the

inner surface of the inner rib, as shown in Figure 2(b). The LEDs are mounted at front, middle, and rear locations on each rib, spaced at 35 mm apart, as determined by an optimization study [9] (Figure 3). Further, each LED has a specific mounting method, vertical position, orientation, and an angle for positioning on the ribs [7]. This combination of optical sensors and LEDs makes RibEye capable of measuring both lateral and oblique rib deflections, a distinct advantage over other systems such as the IR-TRACC, when the ATD is subjected to the oblique loading that sometimes occurs in side impacts.

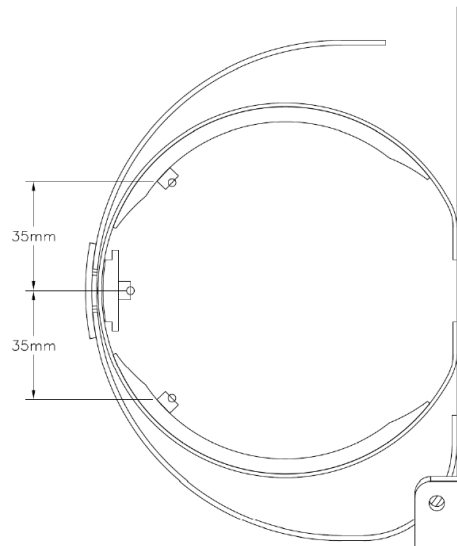
Figure 3. Schematic showing front, middle, and rear RibEye LED locations on a WorldSID-50M rib.

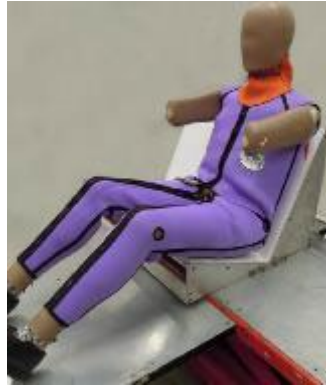
Figure 6. WorldSID-50M dressed in its sleeveless skinsuit.

The original WorldSID-50M skinsuit included sleeves for the arms and contained a sizeable hole under the arm to facilitate arm motion. However, in this configuration, the sleeve fabric could bunch together during shoulder flexion and the hole provided a path for external light to enter the thoracic cavity, potentially interfering with the RibEye functionality. Therefore, a sleeveless skinsuit design has been adopted by NHTSA as depicted in Figure 6. The sleeveless suit provides improved freedom of arm motion without bunching and eliminates the potential light path under the arm.

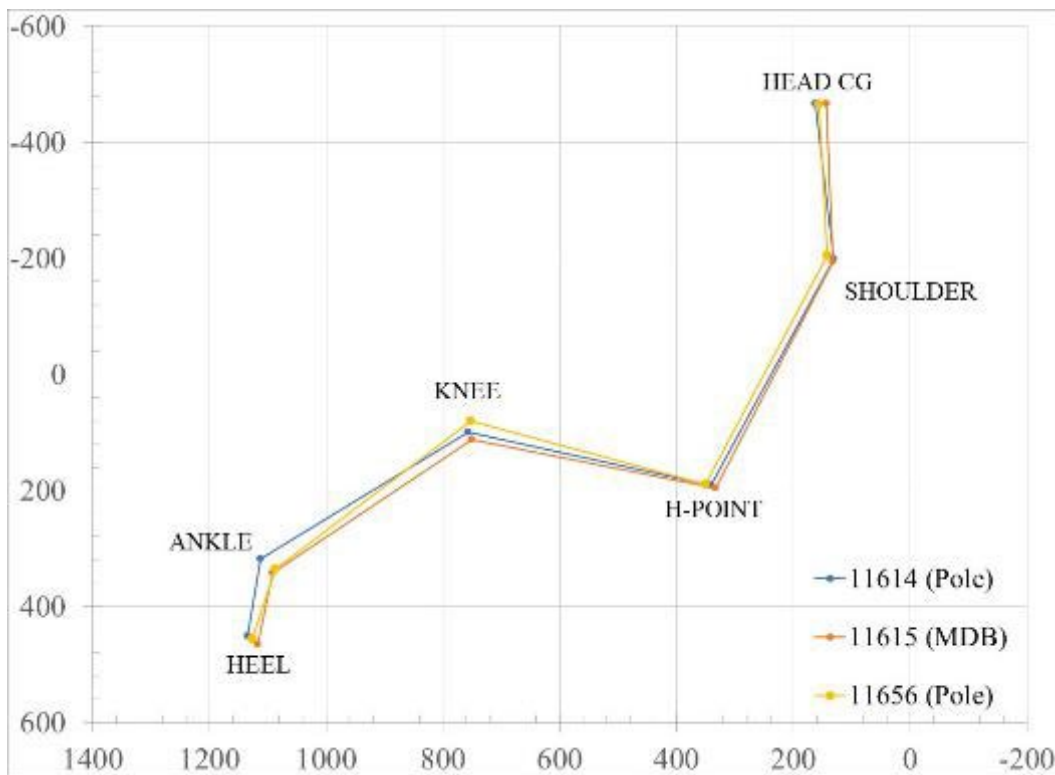
Figure 7. WorldSID-50M Front Passenger: Seated coordinates in three Mini Cooper S convertible tests.

The WorldSID-50M seating procedure was followed to position the ATD in each crash test. The procedure places the seat pan at a mid-angle, at the lowest height position, and typically at midtrack, barring any lower body interference with the trim panels of the vehicle dashboard. Among the vehicles used in the test series, a 2019 Mini Cooper S convertible was used more often than the other vehicle models. A WorldSID-50M unit was seated in the front passenger seat in three Mini Cooper tests. Figure 7 displays a stick figure derived from the Mini Cooper vehicle reports that indicates the relative uniformity of the ATD positioning (WorldSID-50M unit WS-R in all cases). It shows the x- and z-coordinates relative to the door lock striker on the passenger side of the vehicle. Coordinates of high interest are shown in the figure, including the outboard H-point.

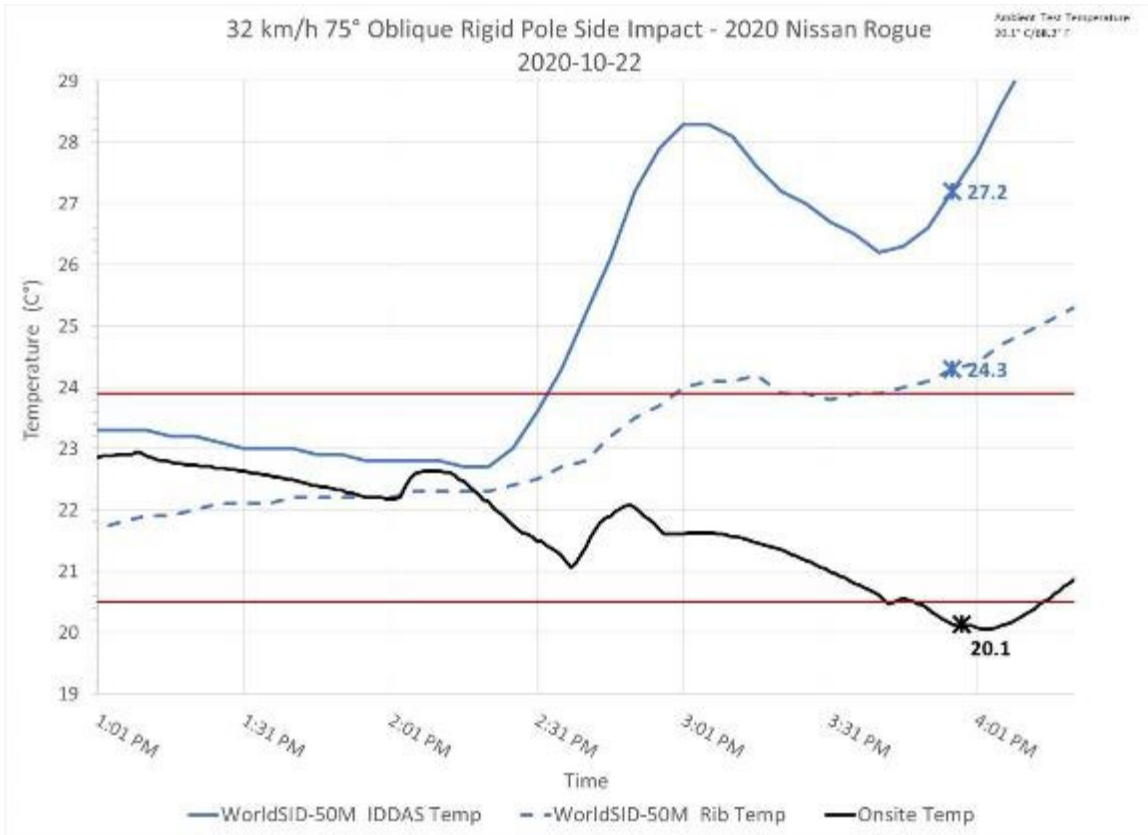
Figure 8. WorldSID-50M Rib Temperature Timeline for Crash Test 11601.

Indeed, elevated rib temperatures were observed in the first three crash tests of this series. There were a few instances where the rib temperature was close to exceeding or did exceed the established upper temperature threshold of 23.9 C. One such test, 11601, in which the rib temperature was slightly elevated at the time of the crash is shown in Figure 8. The black solid line is the ambient temperature of the lab, the solid blue line is the temperature on the RibEye DAS, and the blue dashed line is the temperature of the second thorax rib (impact side). The final

switching 'ON' of the DAS unit in this test occurred ~2:15pm, and the RibEye controller and rib temperatures began to rise. At the lab where the tests occurred, the doors to the setup lab were opened prior to the test, which occurred just after 3:00pm. The colder external air temperature slightly cooled the ATD between bay door opening and firing of the test, but overall temperatures remained elevated due to the DAS. The WorldSID-50M rib temperature at the time of the crash was over the limit by 0.4°C.

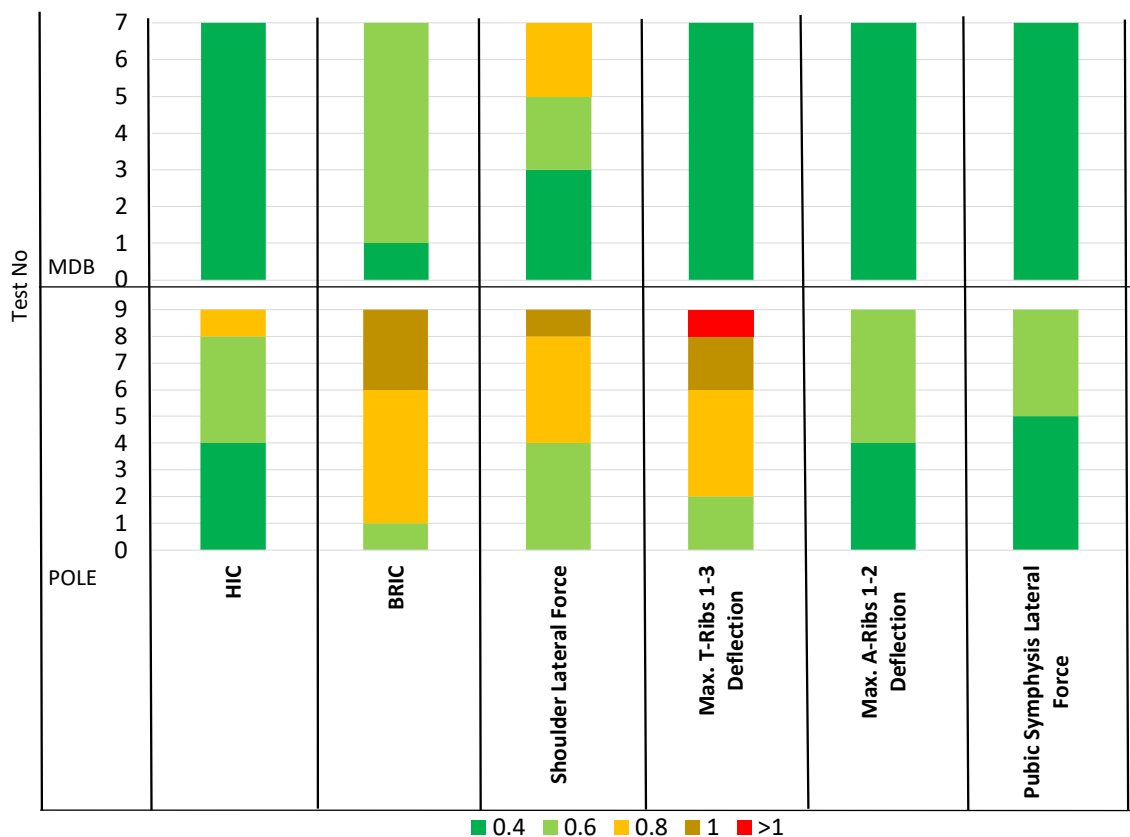
Figure 12. WorldSID-50M: Comparative injury metrics by exposure.

To assess the degree to which the WorldSID-50M units were exposed to a rigorous testing series, ATD injury metrics were assessed after crash testing. Figure 12 indicates the proximity of observed injury metrics to baseline comparative values (Table 2). The coloration of the figure indicates the ratio of the respective WorldSID-50M injury metrics observed in this crash test series to EuroNCAP values:

Figure 12 displays the degree to which the various body regions of the WorldSID-50M were exposed to injurious conditions. In both crash configurations, each body region had at least a couple moderate-risk exposures. By considering Figure 12, it can be concluded that the pole tests were universally more injurious. While maximum thoracic rib deflection was the greatest injury metric in pole tests, the maximum lateral shoulder force was greatest in the MDB tests. In both crash configurations, the pubic symphysis lateral force yields a comparatively low injury metric to all others.

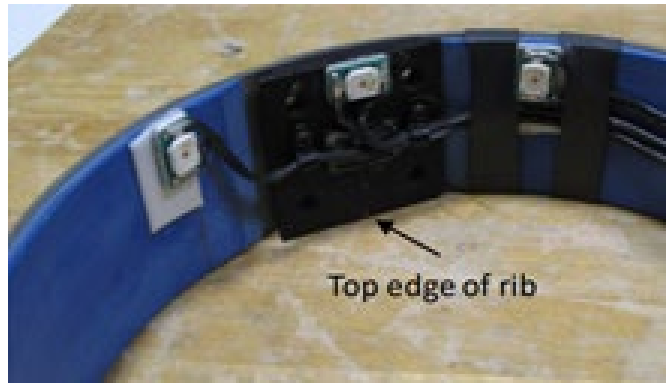
Figure 16. LEDs on thorax rib 1 of the WorldSID-50M after relocation from the centerline to the bottom edge where only the center LED is horizontally oriented.

In response, the 2019 Mini Cooper S convertible was retested in a pole condition with a WorldSID-50M that had updated LED locations. To allow more clearance from the rib above, and potentially prevent future LED blockages,

the LEDs on thorax rib 1 were relocated from the centerline of the rib to the bottom edge of the rib, and the middle LED was rotated to be oriented horizontally (Figure 16).

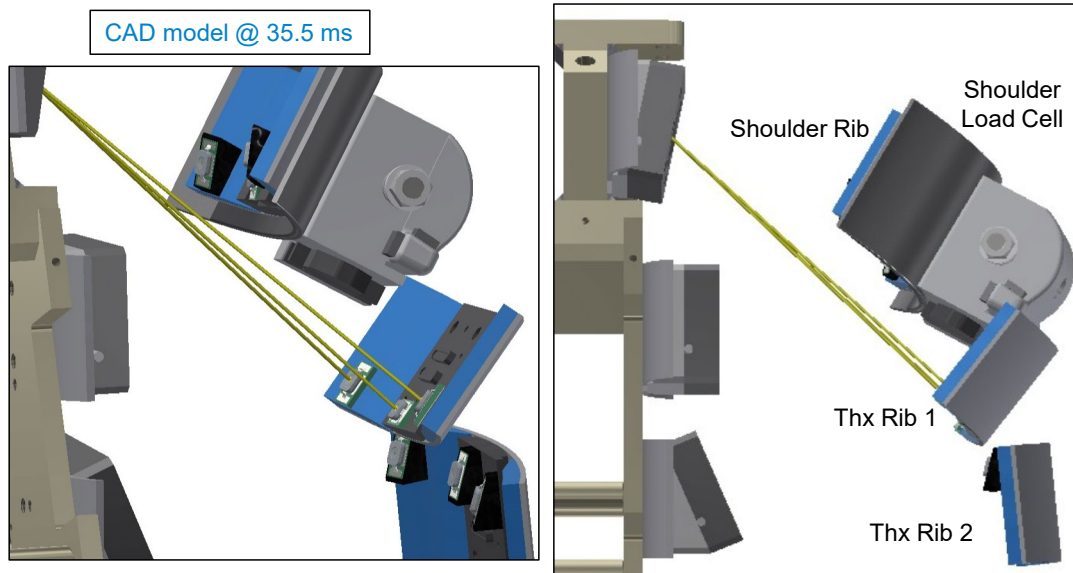
Figure 17. 3D CAD model of the rib motion during crash test 11656 in which the LEDs on thorax rib 1 are visible to the top sensor at maximum deflection.

Once this adjustment was made, test 11656 was conducted as a repeat of the right-side pole test on a 2019 Mini Cooper S convertible with the updated LED locations. An identical 2019 Mini Cooper Convertible was used with all the test setup parameters matching the previous test as closely as possible. Thorax rib 1 did not record any error codes in the repeat pole test, and the thorax rib 1 LEDs were clearly visible to the top sensor, as depicted in the below rendering (Figure 17). By overlaying the rib deflection data of these two tests, it was confirmed that the rib response was nearly identical. Therefore, it can be concluded that the relocation of the thorax rib 1 LEDs resolved the blockage that occurred in the first Mini Cooper test, and the maximum thorax deflection was successfully recorded in the repeat test.
